| <b>1 INTRODUCTION</b> | <b>5</b> |
| 1.2 Pavement failure . . . . . | 5 |

- To replicate a typical pavement in the Accelerated Pavement Test (APT)
- To study the impact of water infiltration on the subgrade as surface loads and cycles increase
- To investigate the influence of thickness of base course on the deformation of the subgrade layer

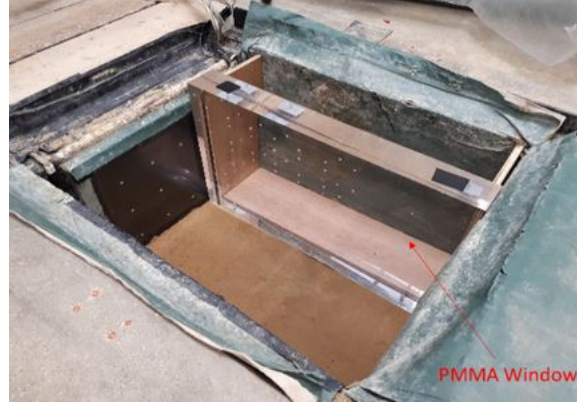
Figure 11: Installed perspex window

A transparent 100 mm thick Perspex (also known as PMMA) window was mounted inside a concrete tank that was 1.0 m deep but filled with Oxford sand up to a depth of 0.50 m, 0.86 m long and 0.80 m wide. The window was placed 18 cm away from one side of the wall (as shown in Figure 11), so that the wheel path was not blocked when the APT was put in place.

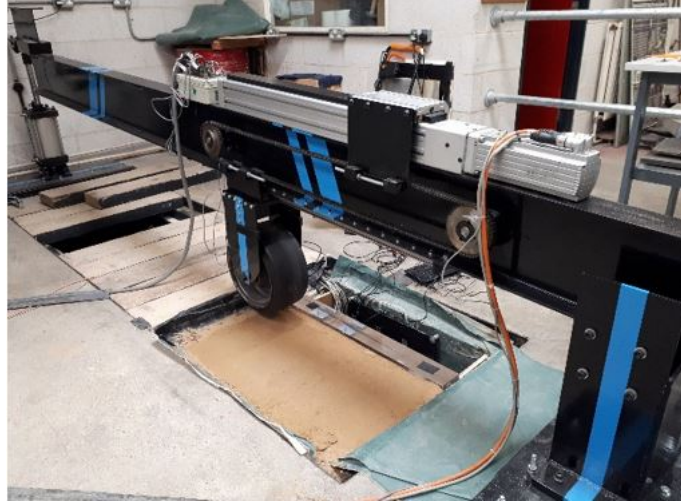
Figure 15: Image of APT

For loading of the tyre, the out-stroke of a pneumatic cylinder lifted the tyre out of contact with the pavement surface while the in-stroke provided the compression at the wheel/pavement interface. As the tyre position and height changed with each pass, the pneumatic actuator must apply a constant load to the pavement surface. The speed, position and load were controlled electronically via a fully automated digital control system. The actuator applied a pressure and the tyre side plate strain gauges measured the associated bending load from the tyre and digitally feedback to the control system, which adjusted the pressure in the pneumatic cylinder until the user input calibrated load was achieved. A feedback loop completed this cycle every 0.5 seconds. When the user-defined load was reached, the motor drive was initialized, moving the tyre forward. The loop continued to adjust the pressure through the entire cycle, ensuring a constant load was applied to the surface through the entire travel path. At the end, the load was released and the wheel assembly was moved back to its starting position. The process was repeated until a user-defined number of cycles or failure criterion was met (Bowman & Haigh, 2016).

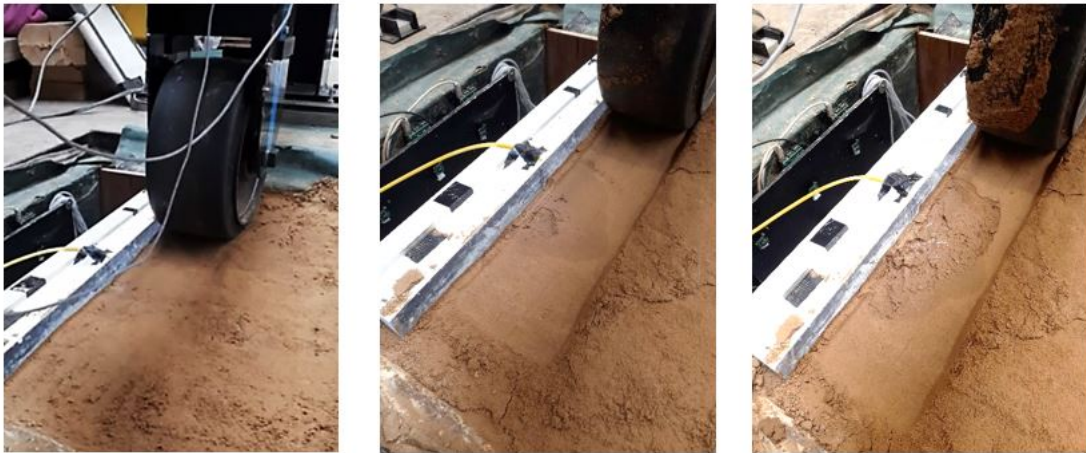
Figure 26: Pothole forming after 2 cycles on wet subgrade

Figure 26 above shows the development of a pothole forming after 2 wheel passes. Water was introduced at the centre of the pavement which can be seen from Figure 26 as well (wet sand has a darker shade than the dry sand). At the first pass, rutting could be observed as the subgrade experienced permanent deformation. As the wheel rolled over the subgrade, the water on the surface was squeezed and pushed forward and affected a bigger area of subgrade, which accelerated the subgrade failure. This explains why the

deformation of the subgrade was bigger in front of the wheel and smaller at the back of the wheel based on PIV results. By the second pass, a large patch of the wet sand could be seen stuck onto the wheel and it was evident that the subgrade has failed. Without the base course, the wet surface of the unbound subgrade layer got carried away easily by the moving tyre. This situation did not occur with the dry subgrade, where only rutting was observed.
