# **Solving the pothole problem**

## **Investigating the use of geotextiles in reinstated-trench pavements**

This report is submitted for the degree of  
*Masters of Engineering*

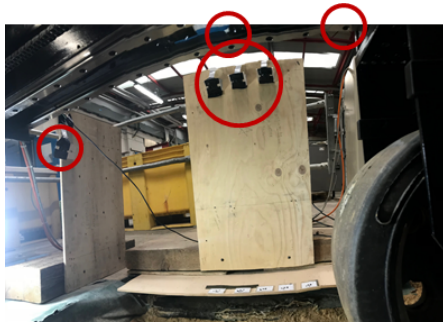
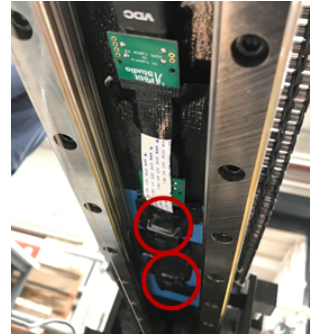
(a) Camera set-up

(b) Cameras under APT beam

Fig. 3.2 Image of Surface Cameras (individual cameras highlighted by red circles)

cameras were screwed onto metal plates on wooden blocks and the remaining two cameras under the APT beam to capture from plan view. A total of ten reference markers were placed on the protruding wooden plank screwed on the concrete floor and on the Perspex window.

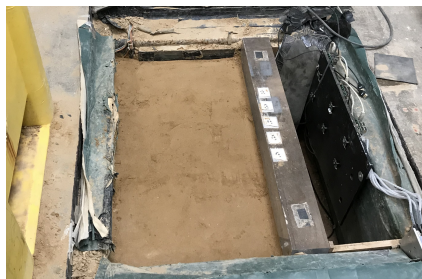
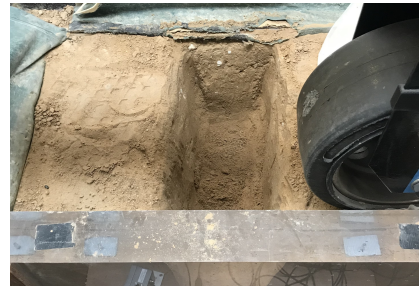
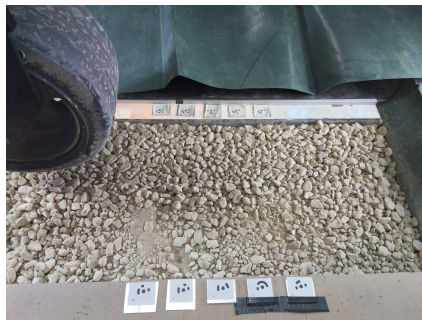
(a) Simple trenched pavement (without APT)

(b) Trench (with APT tyre)

(c) Gravel layer (with APT tyre)

(d) Geotextile Layer (with APT)

Fig. 3.5 Image of Pavement Models

3. The soil was shovelled into the concrete pit by hand in 150mm uncompacted layers and compacted with an electric plate compactor with at least the recommended 3 passes per layer [17]. The soil filled the pit up to the top surface of the Perspex window (Figure 3.5a) and was levelled with use of a spirit level.

5. For model variations with stiff soil, base or reinforcement layers, the silty sand was only filled to the defined height and the variation layers constructed accordingly. For stiff soil, the compaction method in *Step 3* was followed. For base layer, gravel was compacted sub-optimally as the material cannot be compacted well with an electric plate compactor. For reinforcement layer, a single sheet of geotextile was nailed down in the corners to prevent horizontal slip, as shown in Figure 3.5d.

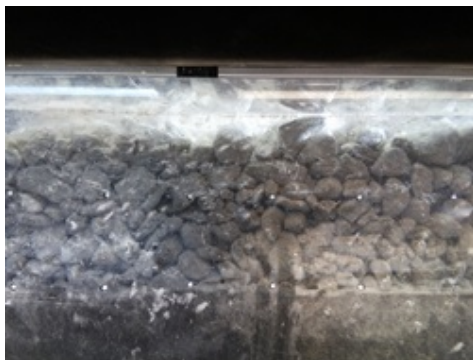
Fig. 3.6 Camera 'Bronn' Elevation Images of Trench 4 Tests

Subsequent tests were done with only the main Perspex. Due to the angular shape of the gravel, its contact against the Perspex window resulted in scratches. As in Figure 3.6, minimal scratches are visible in test T4T1 but the gravel can still be relatively clearly discerned; the gravel scratched the window during the test, and scratches became more numerous in the test T4T2 elevation images. Thus, questionable PIV tracking could be observed in some areas of the displacement fields for Trench 4 and 5 tests. For future research, scratch-resistant anti-fogging coatings [37] could be considered to solve the during-test scratching problem. Alternatively, a removeable barrier could be placed during base course compaction, and removed prior to conducting the experimental test.
