# Tunnelling in Warsaw- Technical Abstract

Tunnelling in Warsaw  
Catherine Tyldsley (ME)  
Fourth-year undergraduate project  
In Group D, 2013/2014

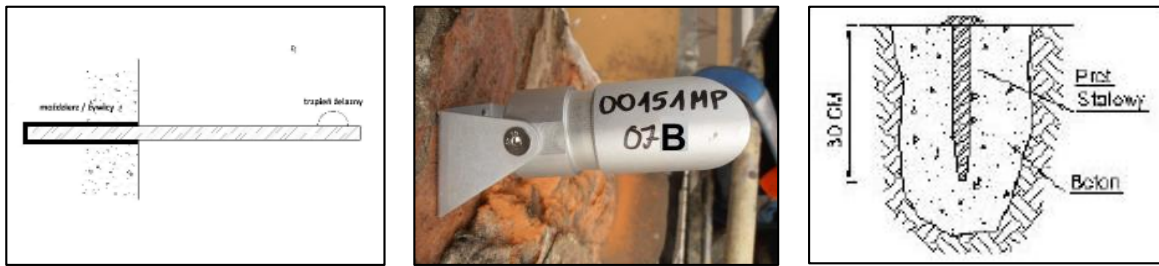
Figure 5.1 Installation of levelling pin, mini prism and ground pin

Three types of monitoring instruments were used to analyse the settlement caused by tunnelling and these were levelling pins (SL), mini prisms (MP) and ground pins (CS). Each were installed and regularly monitored during the construction period. The typical installation of each type of equipment can be seen in Figure 5.1.

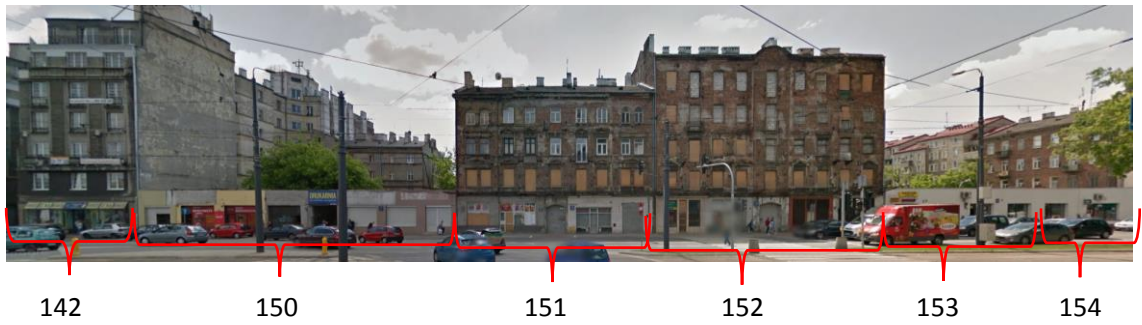
Figure 6.19 Elevation of buildings 142, 150-154

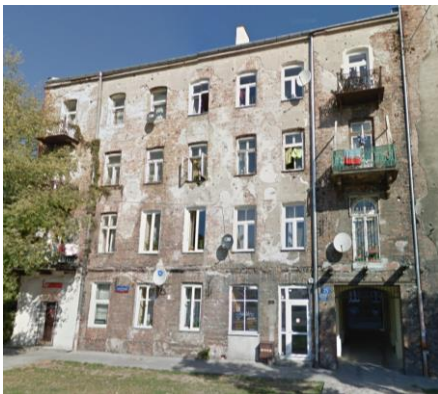
Figure 6.20 Building 128 elevation

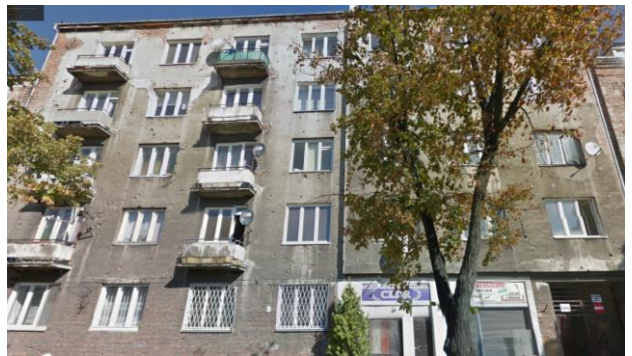
Figure 6.21 Building 129 elevation

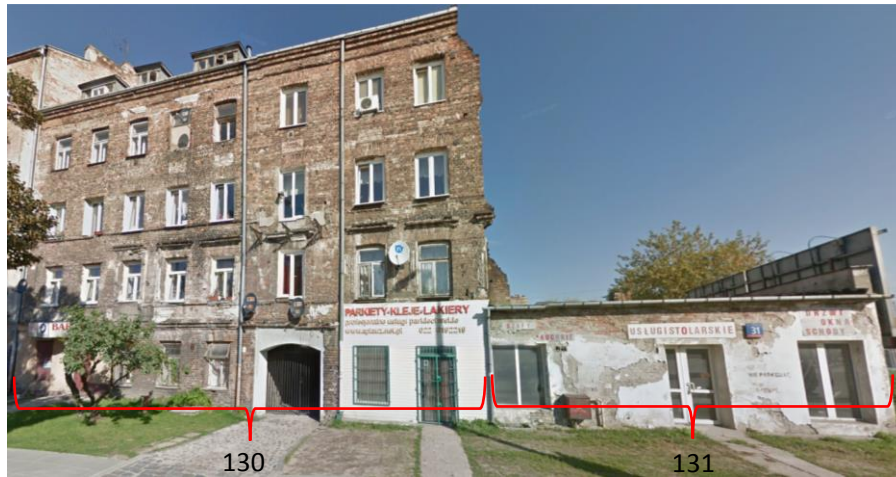
Figure 6.22 Building 130 and 131 elevations
