Seismic Behaviour of Onshore Wind Turbine Foundation on Liquefiable Soil

Juntae Seong (js2501@cam.ac.uk) Supervisor : Prof. Gopal S.P. Madabhushi

University of Cambridge Geotechnical and Environmental Group Workshop 2021

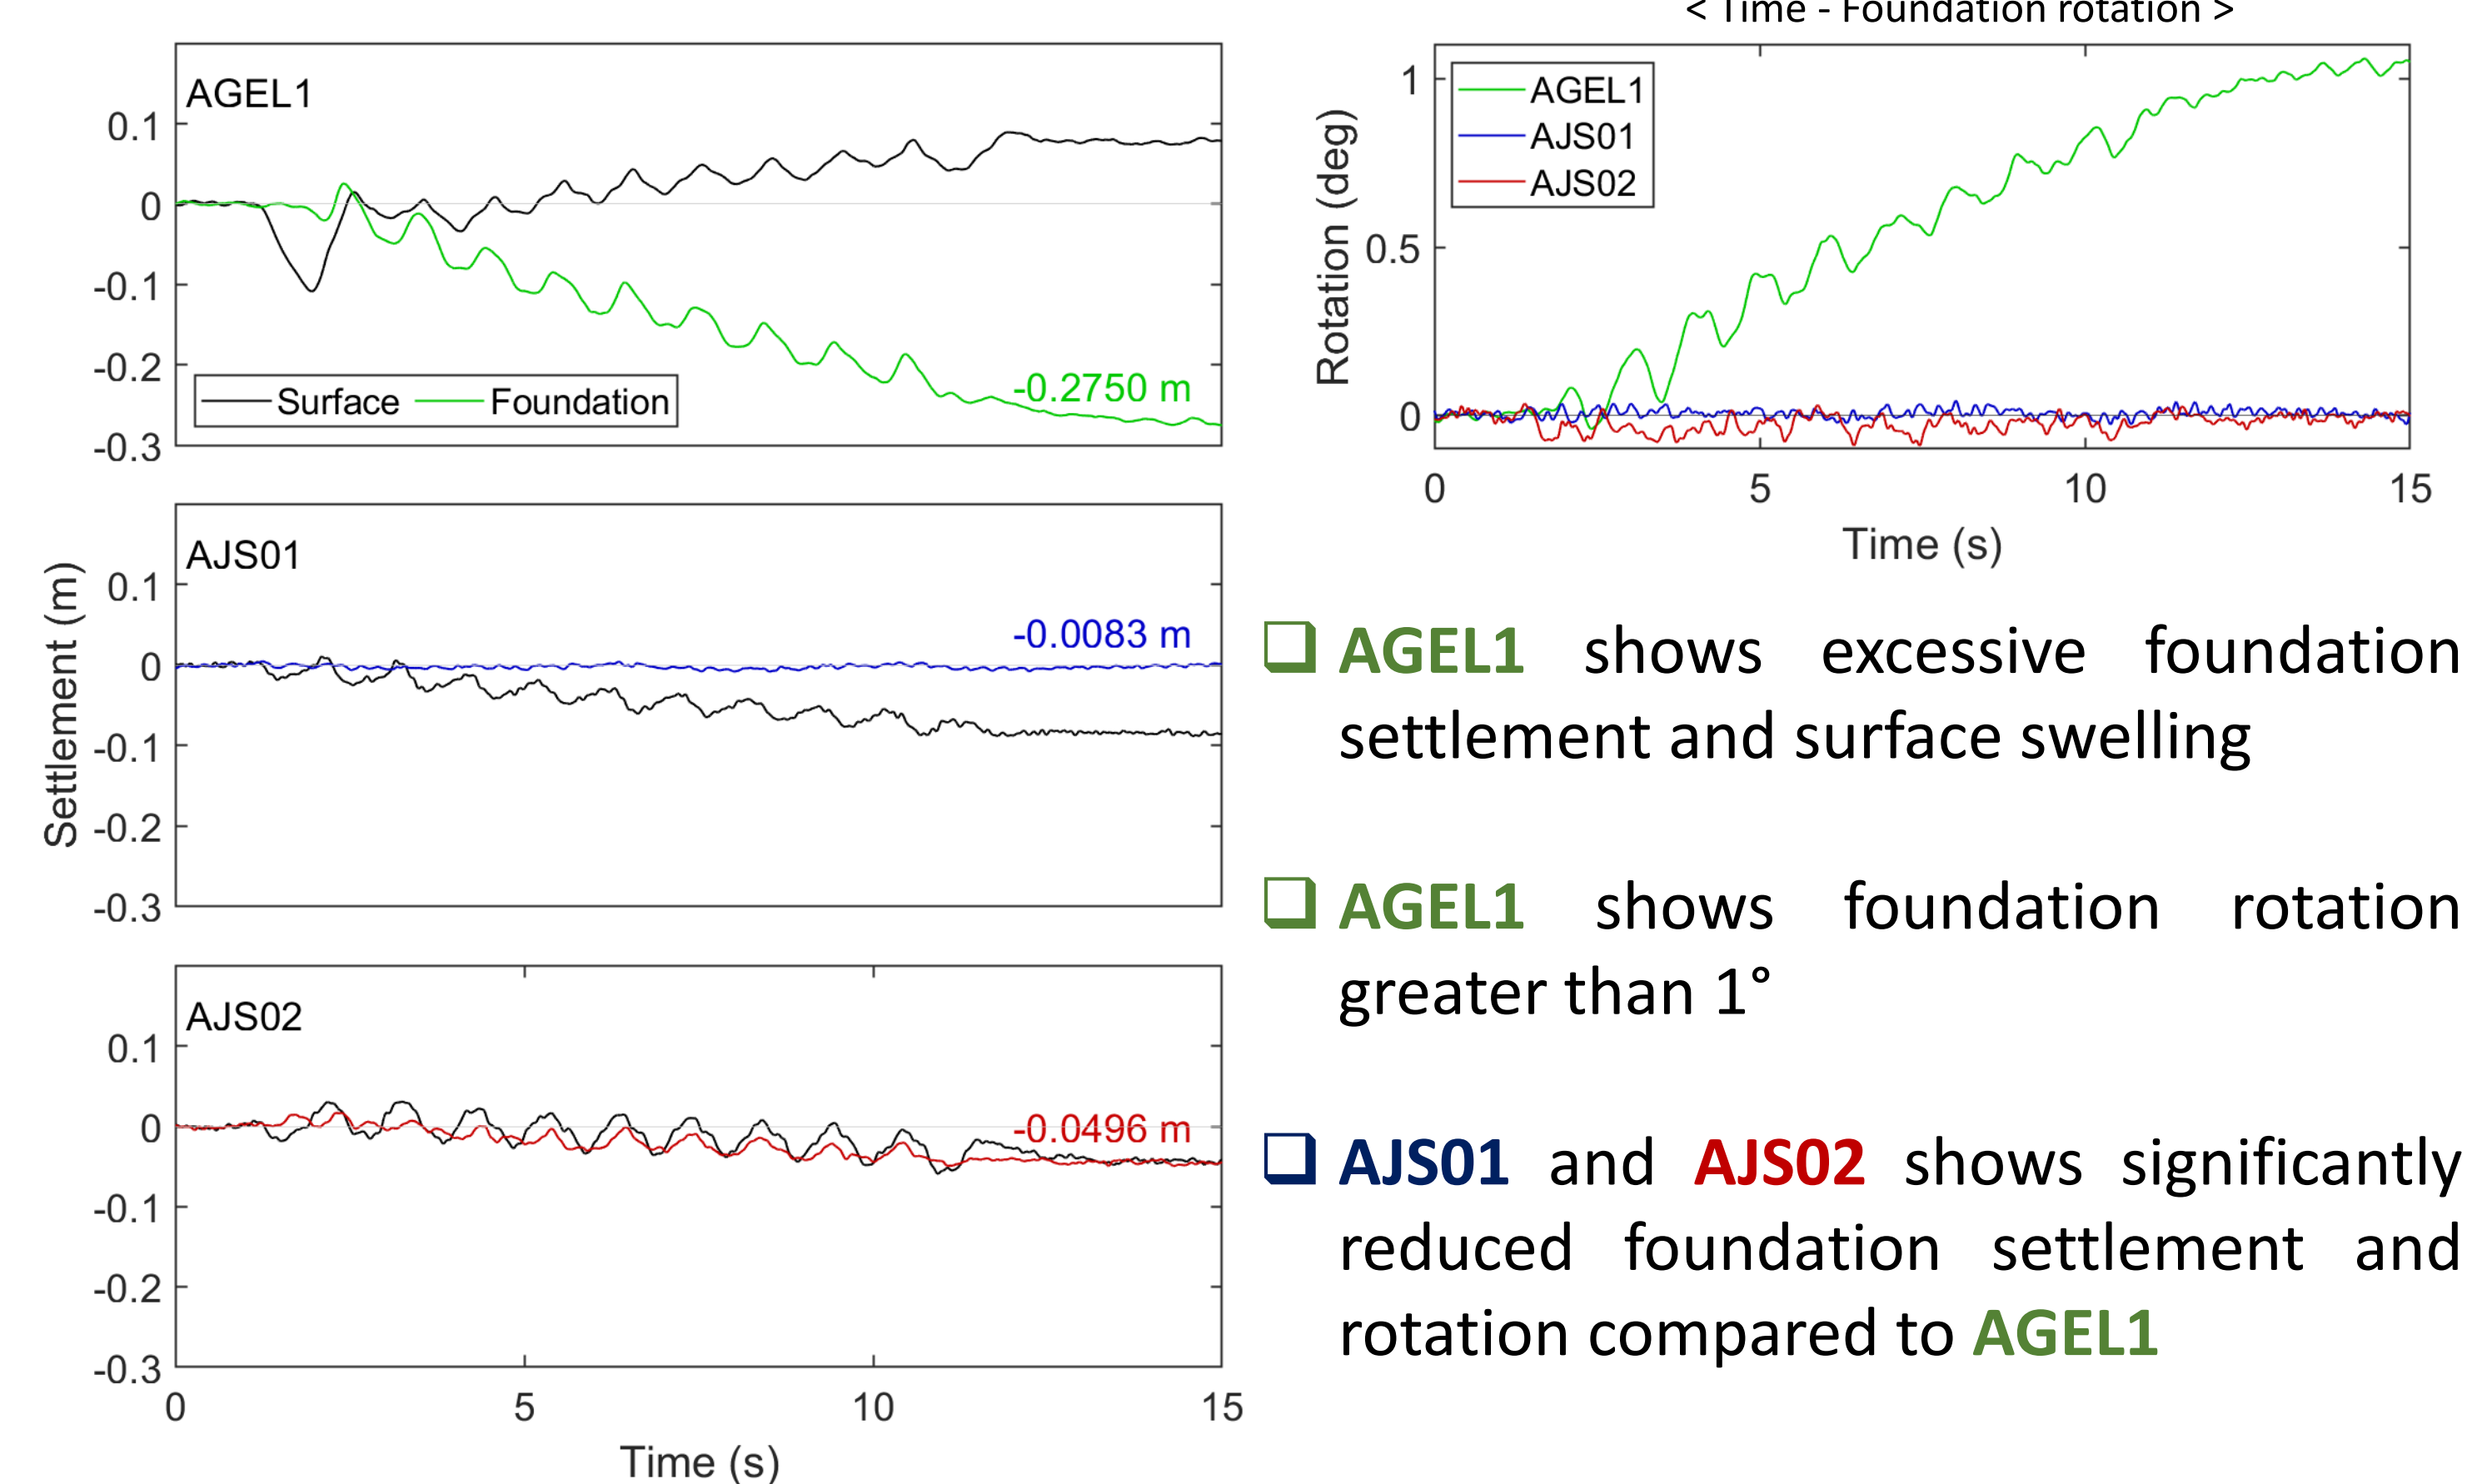
Foundation settlement

- AGEL1** shows excessive foundation settlement and surface swelling
- AGEL1** shows foundation rotation greater than 1°
- AJS01** and **AJS02** shows significantly reduced foundation settlement and rotation compared to **AGEL1**
