# The Influence of Trench Reinstatements on Flexible Pavement Failure

# Technical Abstract

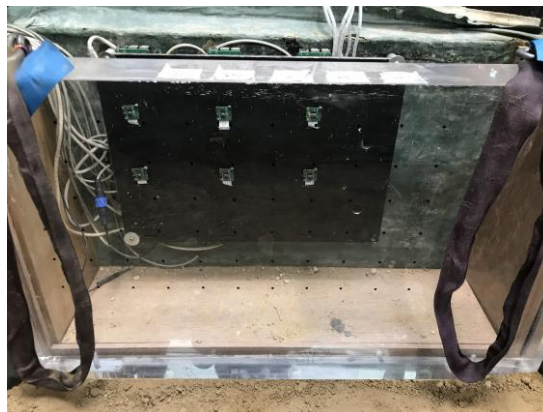
**Figure 15** - Camera setup located opposite Perspex window to monitor soil displacement

Six Raspberry Pi cameras were located on a plate opposite the Perspex window to capture images of the pavement layers during testing. The layout of these cameras relative to the window can be seen in Figure 15. To make sure the whole area of interest was captured, each camera was positioned so that its images overlap with those of the surrounding cameras. For the majority of tests carried out the cameras were set to capture images at intervals of 20 seconds. However, for tests 6 and 7 the interval was reduced to 7 seconds.

To ensure that the images captured were of a high enough quality for future analysis, an LED light was placed on top of the window. A mat was also placed over the top of the gap between the window and the camera plate to prevent any glare.

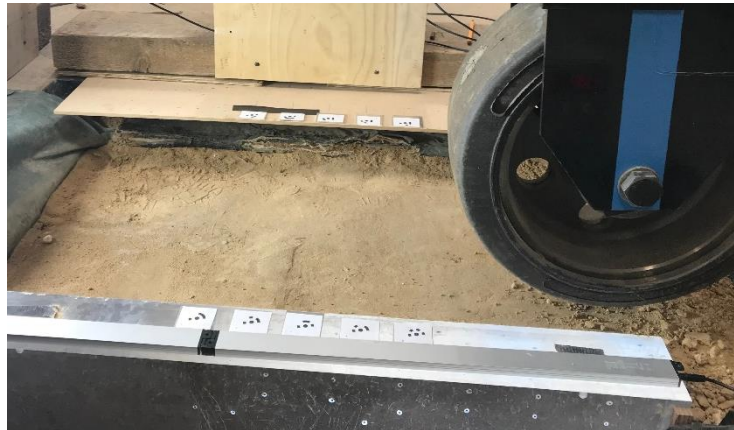
**Figure 19** - Layout of control points used in pavement surface reconstruction

10 control points of known distances from each other were used to scale the 3D models. Figure 19 shows the locations of the control points, with five located on the top of the Perspex and another five on the opposite side of the test section.

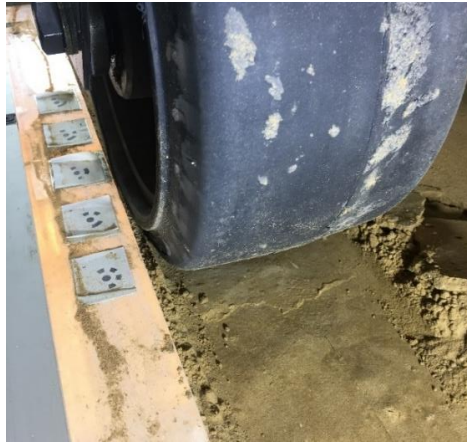
**Figure 22** - Upheaval of subgrade in front of wheel in test 2

In the early stages of each test performed, upheaval of the subgrade in the front of the wheel was witnessed during each wheel cycle. During a cycle, upheaval first became noticeable after the wheel had passed the upward edge of the trench. Upheaval was then continually witnessed over the location of the trench with it most prominent around the trench's downward edge. It is presumed that the upheaval witnessed in front of the wheel is a result of the upward subgrade movement in the front flow zone of Tse (2019) deformation mechanism (Figure 5(a)). Therefore, implying that the subgrade within the trench is failing due to shear.

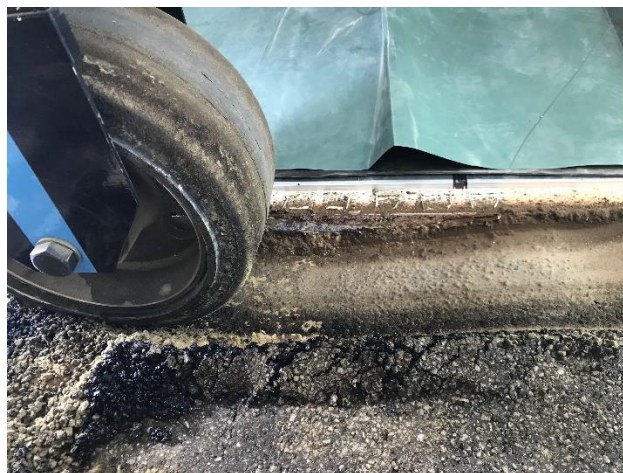
**Figure 34** - Surface rutting present at the end of test 7

The application of cold lay macadam over a subgrade layer proved to be unsuccessful. From the first wheel pass the wearing course layer was seen to fail, with large amounts of shoving in front of the tyre. After only a handful of wheel passes, the cold lay macadam had been removed from the wheel path exposing the surface of the subgrade layer below (Figure 34). The substantial failure of the wearing course was due to the low level of compaction achieved during construction (see section 3.7). A result of this was that the wearing course did not have the required stiffness and strength to prevent embedment and then shoving of the cold lay macadam. Due to the removal of the wearing course, the final deformation seen at the pavement surface was very similar to that witnessed for a single-layered pavement.
